Addenbrookes

OTEX Microbiological Results & Site Survey

March 2008

Addenbrookes Medirest Laundry Photographs.
Site Visit 10th March 2008.

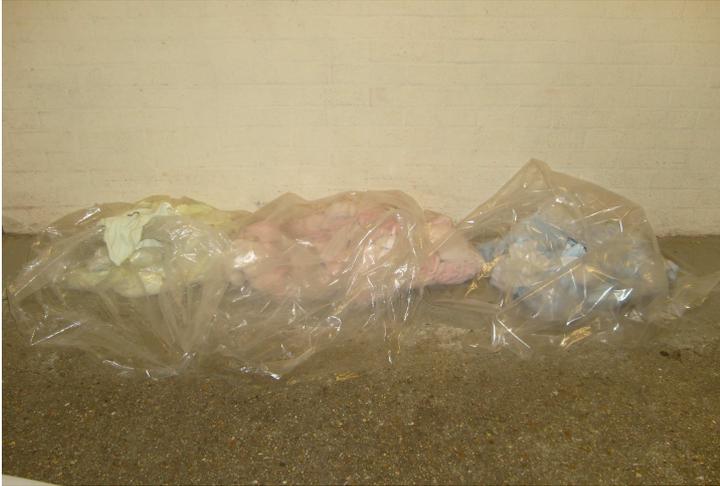
Clean Microfibre Cloths stored on floor in traffic lane of laundry

- Clean laundry stored on the floor.
- Mixed loads – microfibre cloths and mops plus traditional mops were being washed together.
- Overloading of the machines.

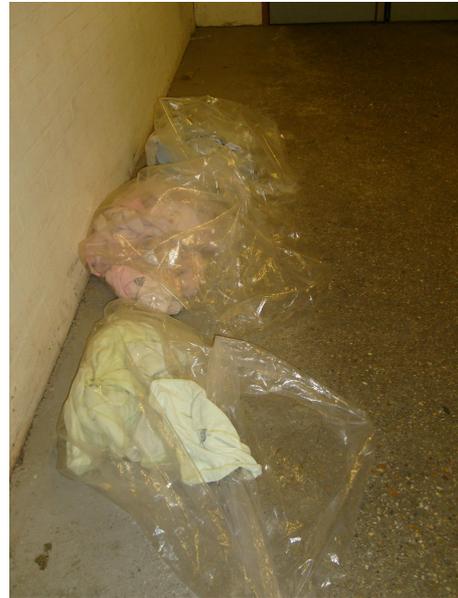
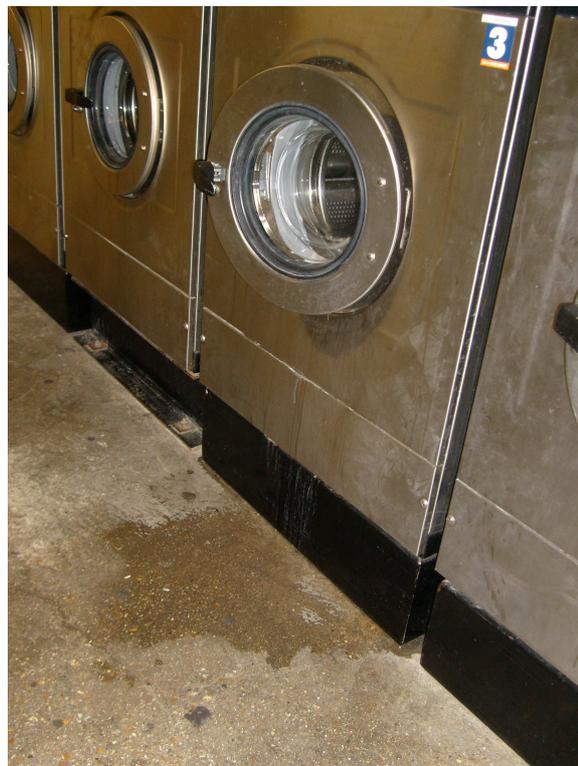
- Washer No 3 was found to be leaking, this had not been reported by site.

Leaking washer not reported

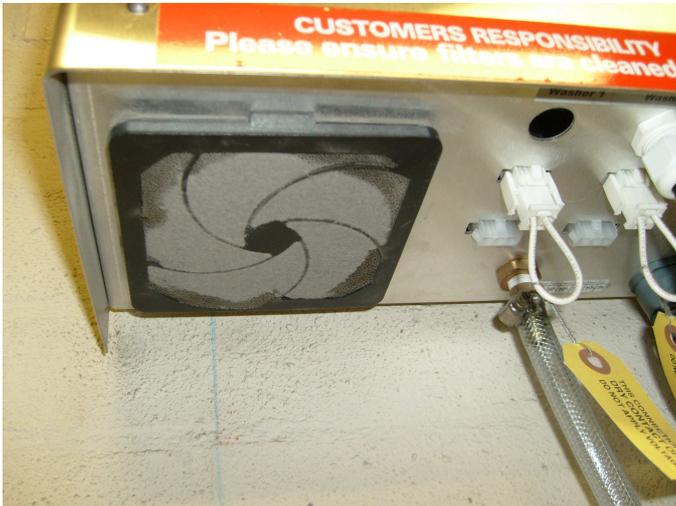
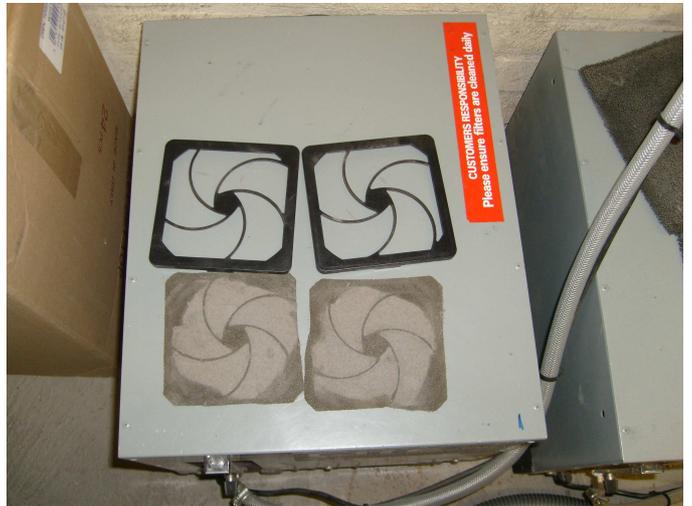
- The filters on both oxygen and ozone generators were found to be extremely dirty. It is vital that these filters are regularly checked. Blocked filters can again result in the units having restricted airflow and overheating. This could have an adverse effect on the level of ozone being produced. The units have been clearly labelled to remind staff that they should be cleaned regularly. Upon the site visit staff operating the laundry were again made aware of their obligation to carry out these checks and keep the area free of any obstructions.

Filters not cleaned

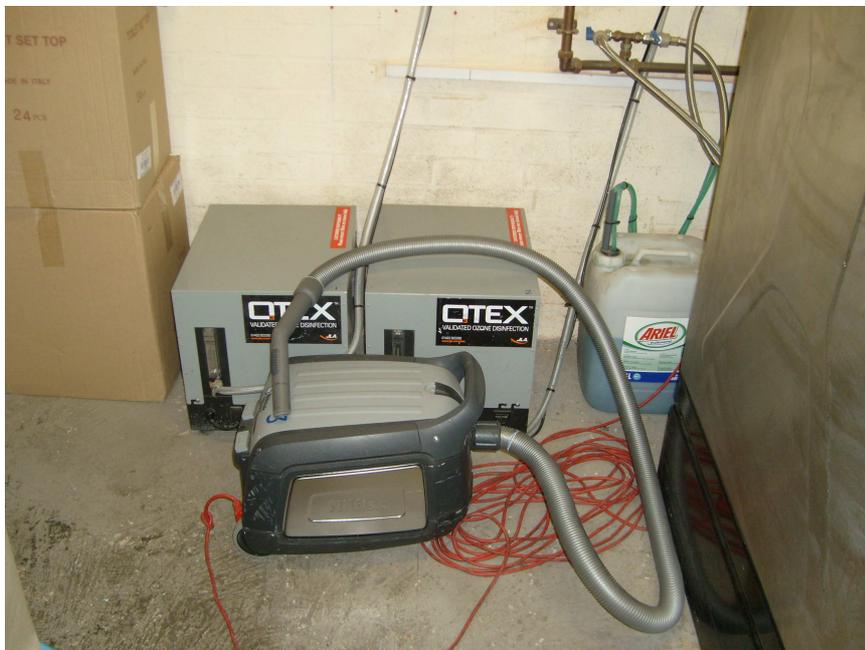
- The area around the oxygen generators was untidy and cluttered resulting in restricted airflow around the units, the storage of a vacuum cleaner in front of the unit did not assist in this. . Both units had been pushed together, again restricting the airflow. It is vital that the oxygen generators have a good flow of air supply so that a sufficient amount of oxygen can be produced for the OTEX system.

Obstruction of oxygen generator.

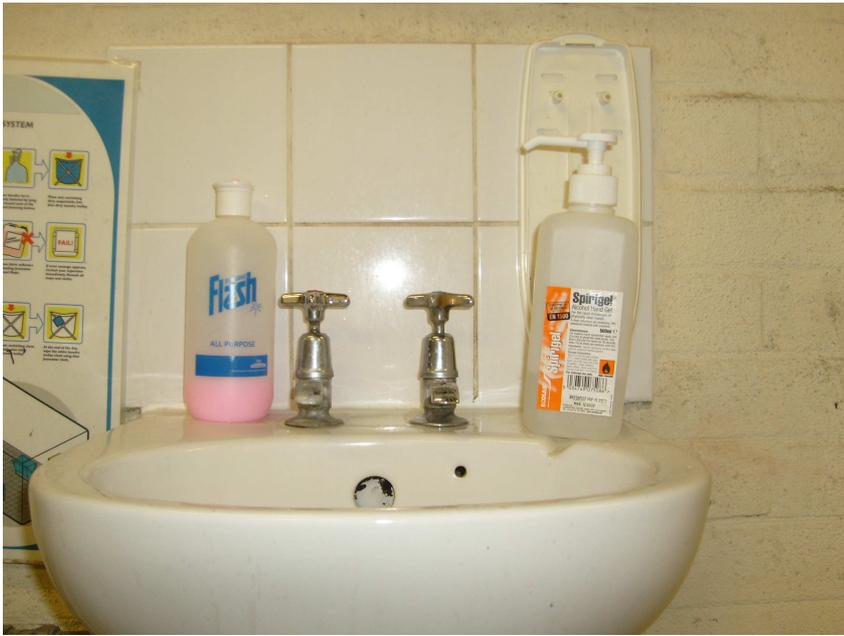
- No hand washing was observed for any of the staff working in the laundry or those depositing dirty laundry at the time of the site visit.
- No soap appeared to be available. Only washing up liquid or what appeared to be Flash purpose.

- The hot water supply was extremely hot, making it unbearable to adequately wash hands. The temperature needs to be reduced either locally with a thermostat valve or provision of a mixer tap should be considered.

- The hand-washing sink within the laundry was being used to drain mop buckets. This resulted in the spent fluid being spilled in the area where the clean microfibre cloths were being stored on the floor.

Hand washing facilities

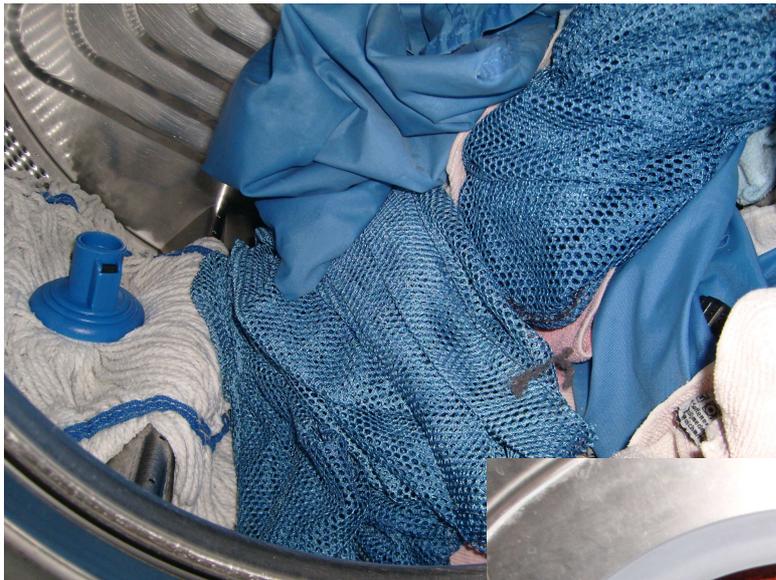
Mixed wash loads

- Training needs to be reviewed.
- Some kitchen items ie oven gloves, were being laundered within the machines on a microfibre wash programme this is unsuitable for such items.

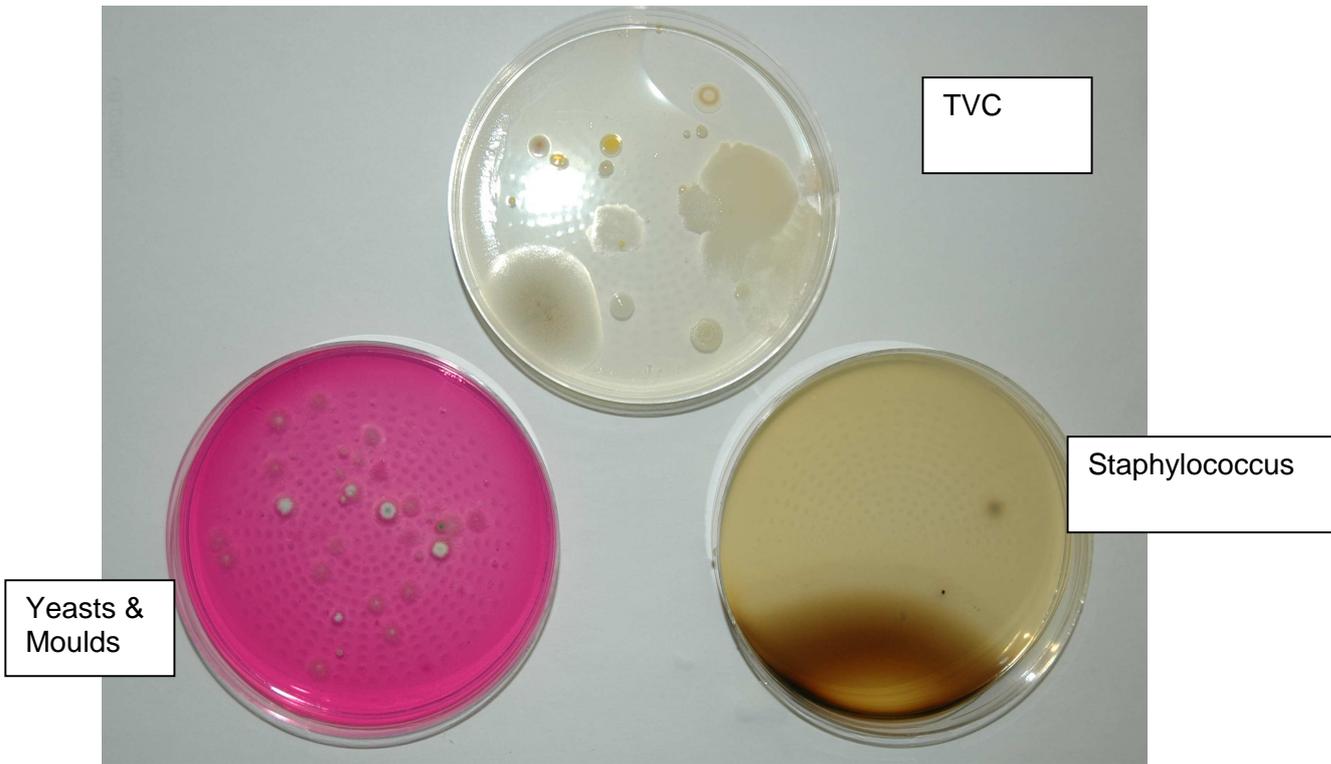
Set 1: Floor area near stored clean cloths.

Sample	Date	Colony Forming Units / litre (CFU/Litre)				
		TVC	S.aureus	MRSA	Yeasts	Moulds
Floor near clean cloths	13 02 2008	9.20E+01	3	<1	3	36
Above washers	13 02 2008	TNTC	<1	5	158	370
Mop Storage	13 02 2008	2.90E+02	42	11	78	279
Outside Laundry	13 02 2008	8.00E+01	2	<1	14	58
