Hospital Microfibre Bacteriological Monitoring Visit – Kings Mill Hospital, Nottingham

Date: 30th September 2006

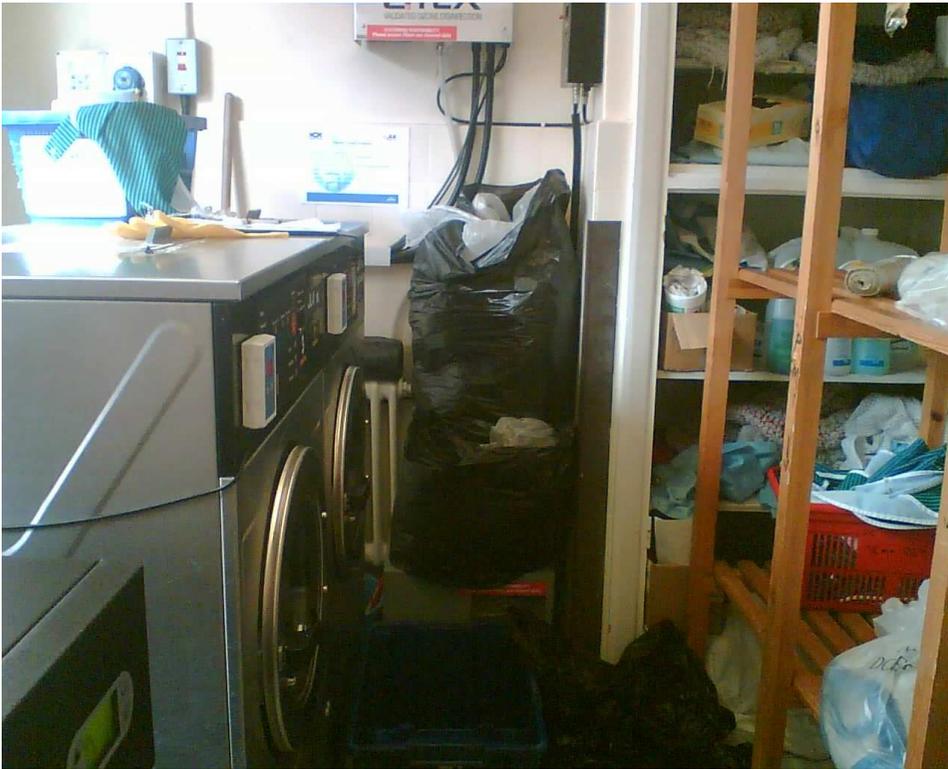
- The area around and above the oxygen generator is congested and full of plastic bags. This unit needs to be kept free from any obstruction. Restricting the airflow will have a detrimental effect upon the ozone production process.
- The oxygen generator filter is missing.
- The filters on the OTEX ozone unit were found to be extremely dirty. Blocked filters will have a detrimental effect on the ozone production process.
- Staff were using the Denim cycle rather than the mop cycle for drying.

Congested area around oxygen generator

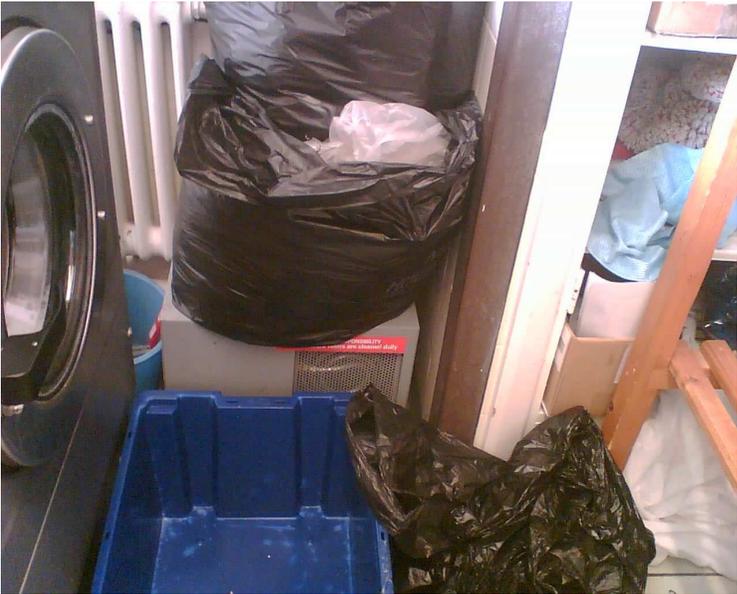
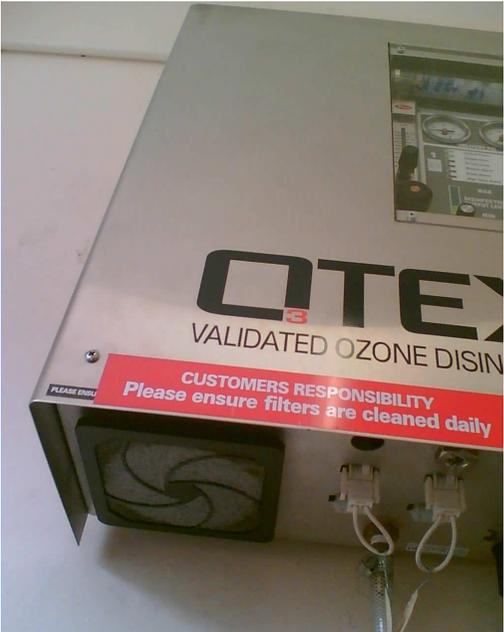
Blocked filter on ozone generator.
